Manhole Inspection Summary

Manhole # S05AA2037MH

Insp Date: **8/17/06 12:00 AM**

Location Address: **5924 KEY AVE**

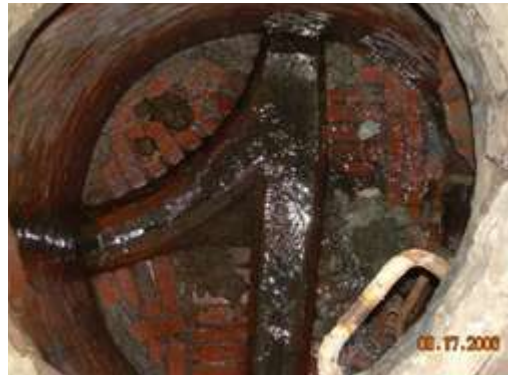
Top View

Corroded steps. Bench debris.

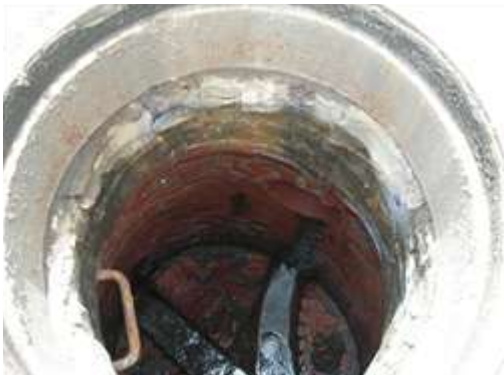
Defect

Frame leaks. Adjustment deterioration and infiltration. Corbel and Barrel infiltration.

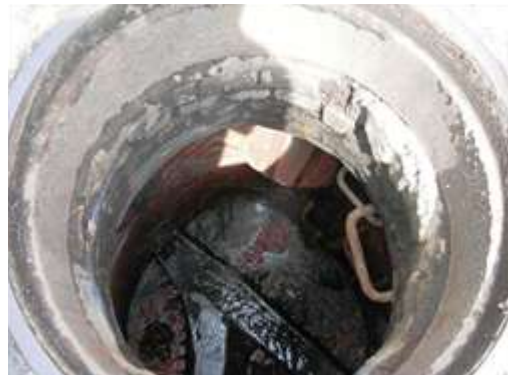
Defect

Frame leaks. Adjustment deterioration, loose brick and infiltration. Corbel and Barrel infiltration - other side.

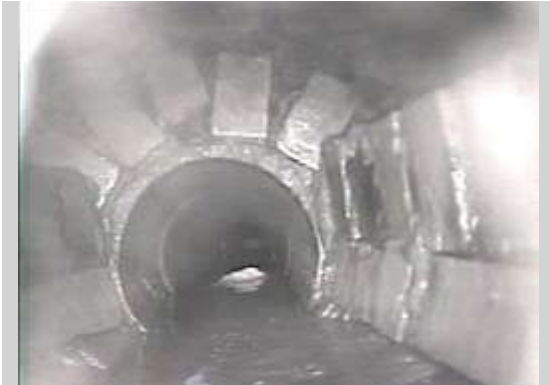
8 in. Circular Gravity Sewer Pipe Out @ 12 O'Clock

Barrel deterioration and infiltration. Channel deterioration.

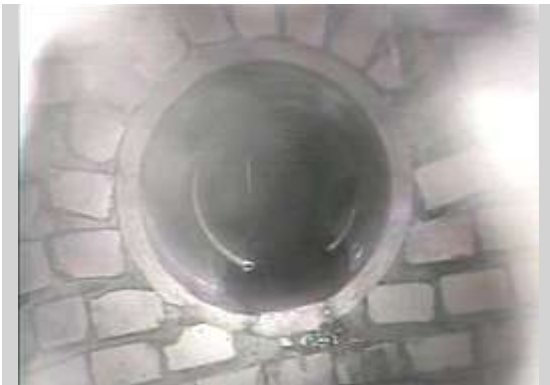
12 in. Circular Gravity Sewer Pipe In @ 3 O'Clock

Corbel root intrusion and infiltration.

Infiltration: **Evidence** Pipe Seal Cond: **Cracked**

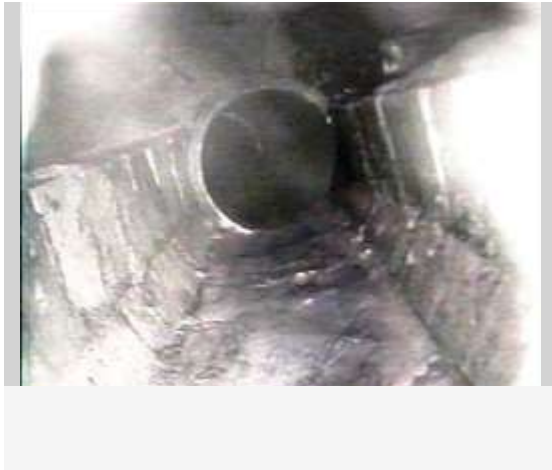
Pipe In @ 6 O'Clock

Infiltration: **Evidence** Pipe Seal Cond: **Unknown**

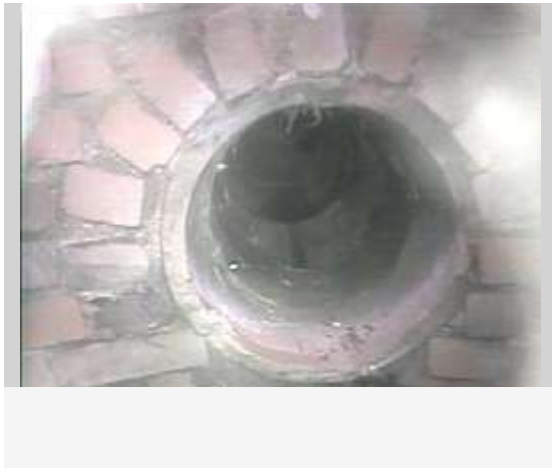
Pipe In @ 9 O'Clock

Infiltration: **Evidence** Pipe Seal Cond: **Unknown**

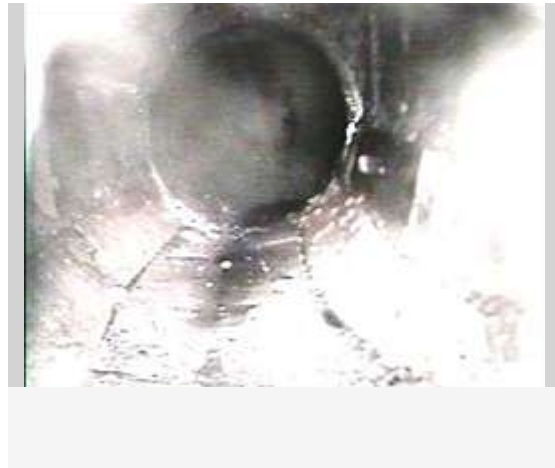
Drop In @ 9 O'Clock

Comments **The I9 pipe is a 12 inch pipe; however the Drop Extension is an 8 inch pipe.**

Drop: **Outside** Rod and Bar
Angled: **Yes** Reading: **7.94** (ft.)
Inv Depth: **8.94** (ft.)
Drop Condition: **Open**
